GUIDE TO THE PREVENTION AND RESTORATION OF EARLY JOINT DETERIORATION IN CONCRETE PAVEMENTS

DECEMBER 2016

1. Report No. IHRB Project TR-697	2. Government Accession No.	3. Recipient's Catalog No.	
4. Title Guide to the Prevention and Restoration of Early Joint Deterioration in Concrete Pavements		5. Report Date December 2016

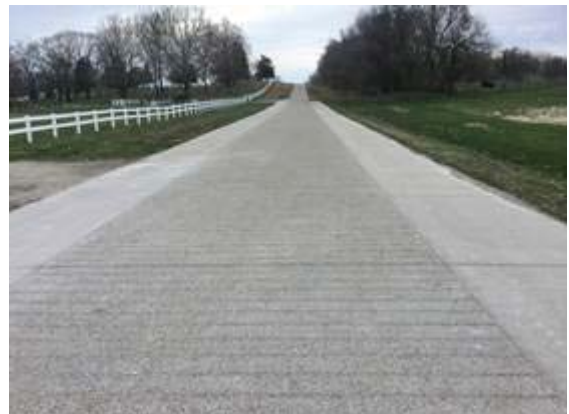
Figure 1-1. Eddyville, Iowa, cemetery road in spring 2016 (photo courtesy of Kevin Merryman, Iowa DOT)

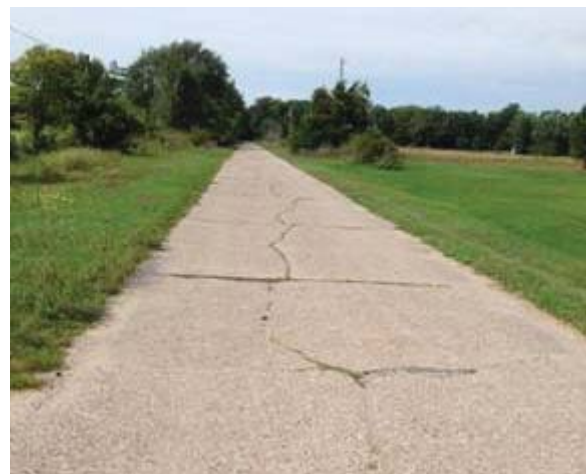
Figure 1-2. Moscow road in 2014 (photo courtesy of Kurt Smith, Applied Pavement Technology, Inc.)

Since Iowa's first portland cement concrete pavement was constructed in Le Mars in 1904 (Hanson 2009), engineers have observed joints from a design as well as a performance standpoint. Many concrete pavements built in Iowa with durable materials and good construction techniques have performed well beyond their estimated design lives. Two examples are the Eddyville cemetery road placed in 1909 and still in service today (Figure 1-1) and a 16-foot (ft) wide pavement with 25-ft transverse joints near Moscow, Iowa, which was placed in 1914 and is in service today as a bike trail (Figure 1-2).

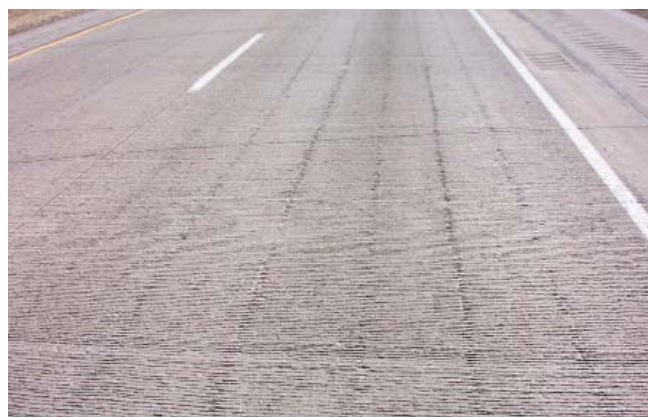
Figure 1-3. Vibrator trails

In 1991 a section of U.S. 20 in Hamilton and Webster counties, which was placed in 1987, began to show visible deterioration at the joints and along vibrator trails (Figure 1-3). Similar deterioration began to appear on several other paving projects placed between 1986 and 1994. Several research projects identified the cause as a loss of air at the joints and in the vibrator trails, increasing the pavements' exposure

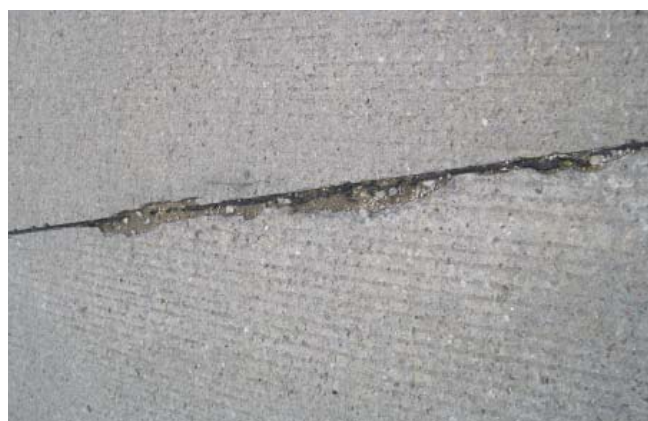
Figure 1-4. Joint deterioration (Photo courtesy of Jim Grove, FHWA)

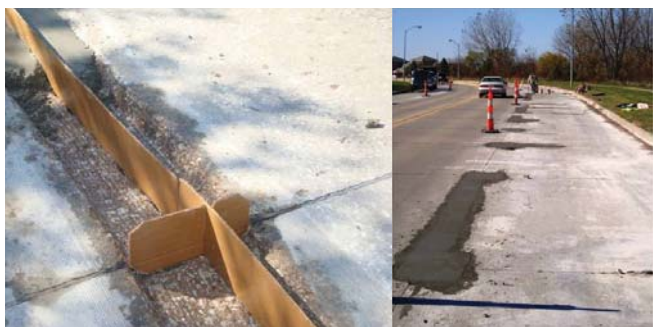
Figure 5-2. Milled joint for removal of spalling (left photo) and finished PDR (right photo, courtesy of City of West Des Moines, Iowa)

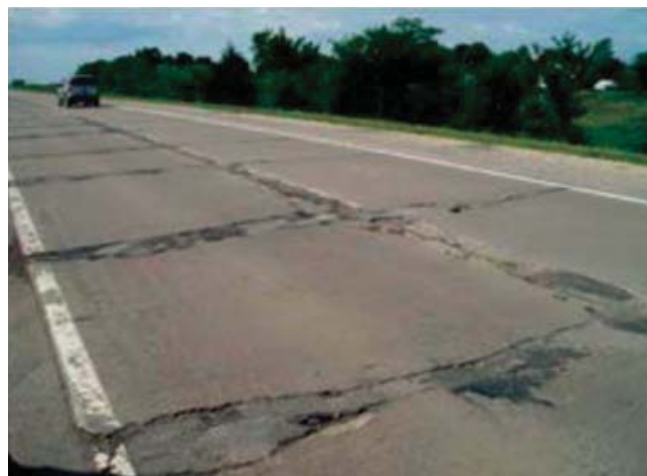
Figure 5-5. Concrete pavement with severe joint spalling (photo courtesy of Todd LaTorella, MO/KS ACPA)

Figure 5-5 shows a concrete pavement in Missouri with severe joint spalling. After careful examination of the pavement, it was decided to construct an unbonded concrete overlay. The

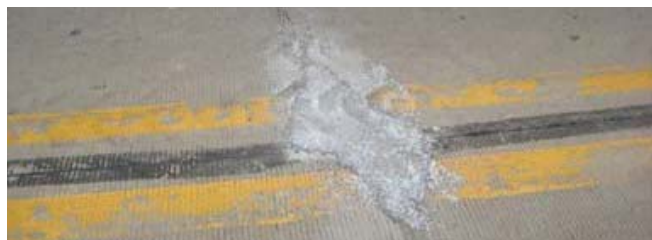
Figure 5-6. Pre-overlay repair of spalled joint (photo courtesy of Todd LaTorella, MO/KS ACPA)

spalled joints were milled and patched with a flowable mortar to fill the void (Figure 5-6). Bonding agents were not used for the patch, and the joints were not re-established.

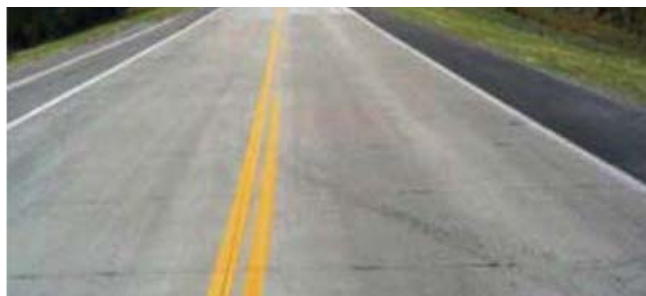
Figure 5-7. Completed unbonded concrete overlay (photo courtesy of Todd LaTorella, MO/KS ACPA)

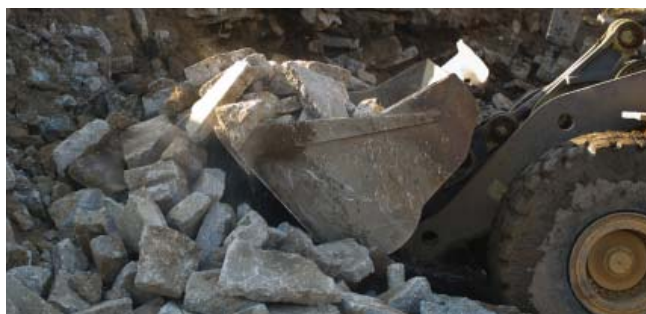
Figure 5-8. Concrete pavement for recycling (photo courtesy of Michigan State University)

In some instances in which pavement deterioration is beyond the state of feasible repair with PDR, FDR, or unbonded concrete overlay, appropriate option is reconstruction in place. Recycling concrete pavements into a base for the new pavement has proven to be a successful option. Recycled concrete aggregate (RCA), as a rule, is a high-quality material for unbound or stabilized applications such as bases compared to conventional new aggregate. An RCA has a rougher surface texture, higher shear strength, higher rutting resistance, and higher resilient modules (Van Dam et al. 2012) (see Figure 5-8).

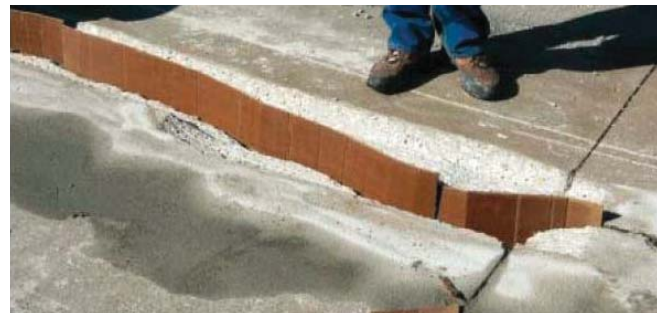
Figure 6-3. Joint board
